PIP5817 Hot Idle Tick Noise from Engine

Brand:	Model:	Model Years:	VIN:		Engine:	Transmissions:
			from	to		
Chevrolet	Silverado 1500 (New Model)	2021	All	All	2.7L (L3B)	All
GMC	Sierra 1500 (New Model)	2021	All	All	2.7L (L3B)	All

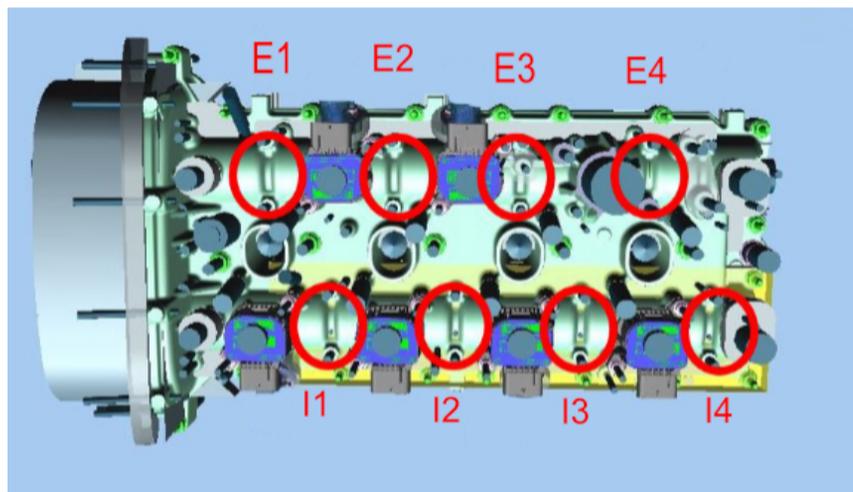
Some customers may have a concern of tick noise at hot idle from the upper engine.

This noise will occur at valve train speed, increase and decrease with RPM and may become louder as the engine temperature increases.

Carefully place the tip of a stethoscope at the locations shown below to isolate the area of the noise.

Once the noise is isolated, remove the Camshaft Carrier Cover following all GSI procedures.

Do not replace Stationary Hydraulic Lash Adjusters or Roller Finger Followers unless damage or performance issues are confirmed.

Replace either the Intake Camshaft or Exhaust Camshaft based on the location of the noise isolated using the Stethoscope.
